# INFRARED THERMOGRAPHIC INSPECTION REPORT

Electrical Distribution and Control Equipment Survey

**Sample Manufacturing Facility**

Aug 12, 2026

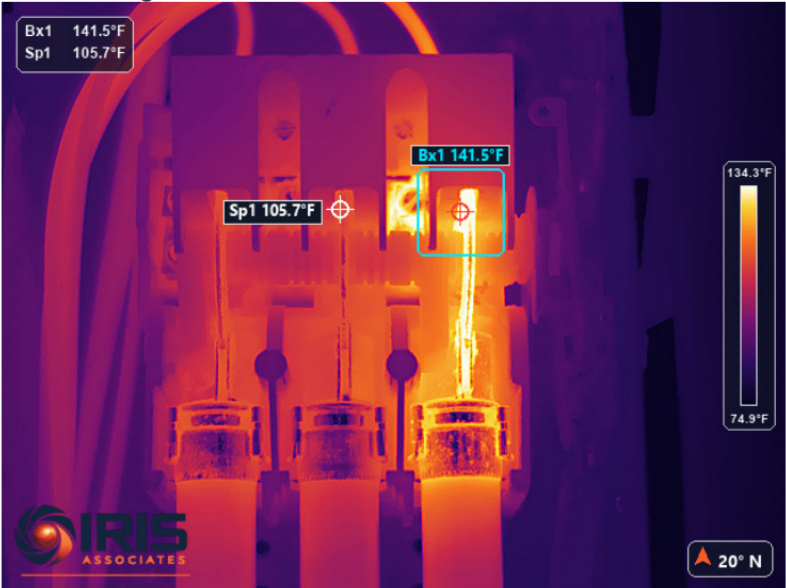
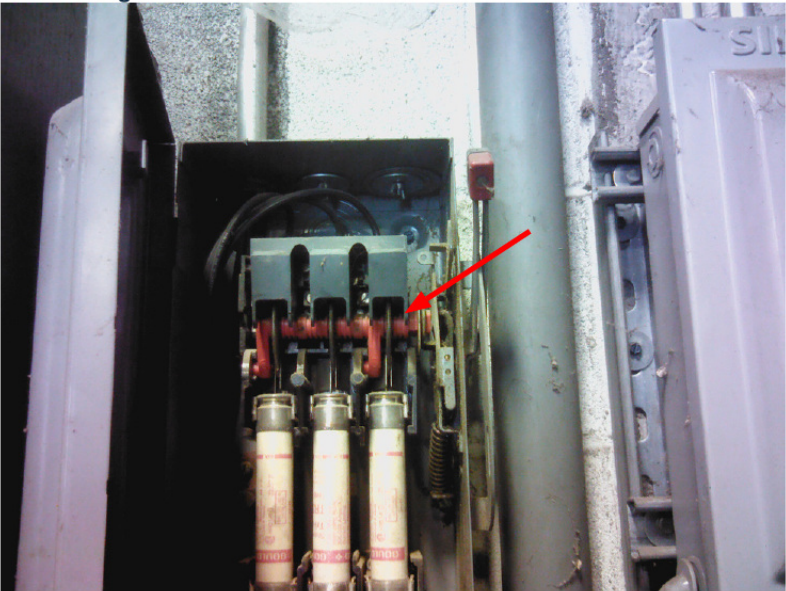
Disconnect B, Air Compressor No. 2

MEDIUM PRIORITY

| Measured Temp<br>141.5 °F | Reference Temp<br>105.7 °F | Delta T<br>35.8 °F |

The right switch hardware is operating significantly warmer than comparable components. This pattern is consistent with increased resistance at the connection or contact assembly.

Investigate The Switch Contacts And Hinge Areas For Signs Of Overheating, Contamination, Wear, Or Damage. Exercise The Switch If Appropriate And Inspect All Contact Surfaces. Clean, Repair, Or Replace Components As Necessary.

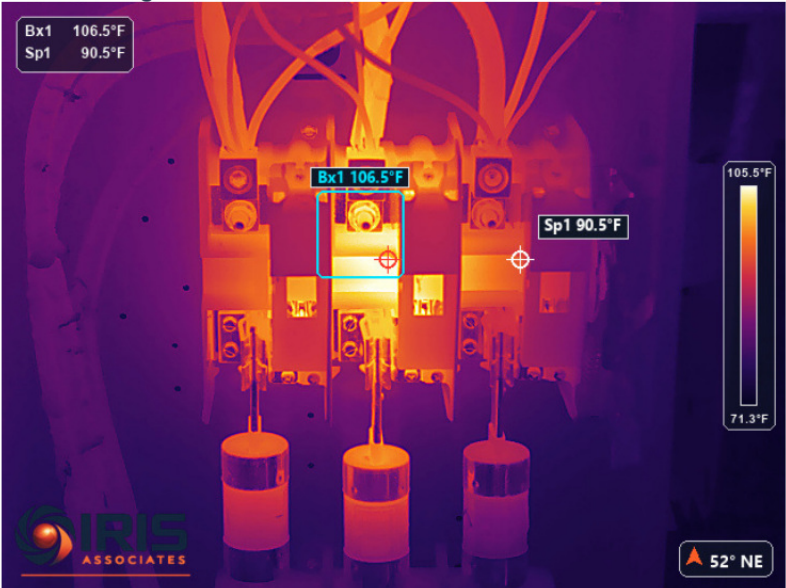
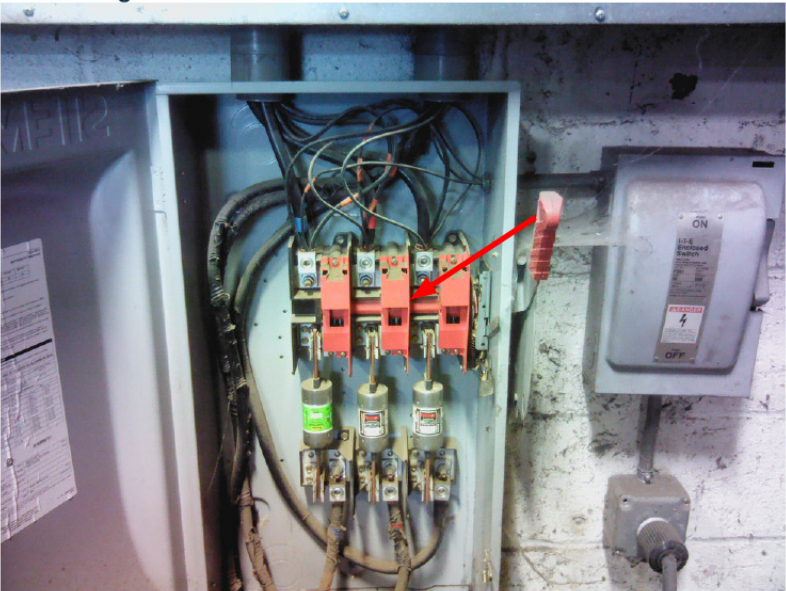
Production Line No. 1 Feed Disconnect

LOW PRIORITY

Measured Temp  
106.5 °F

Reference Temp  
90.5 °F

Delta T  
16 °F

The center switch contacts exhibit abnormal heating relative to the adjacent phases. The temperature pattern is consistent with increased contact resistance.

Investigate The Switch Contacts And Hinge Areas For Signs Of Overheating, Contamination, Wear, Or Damage. Exercise The Switch If Appropriate And Inspect All Contact Surfaces. Clean, Repair, Or Replace Components As Necessary.

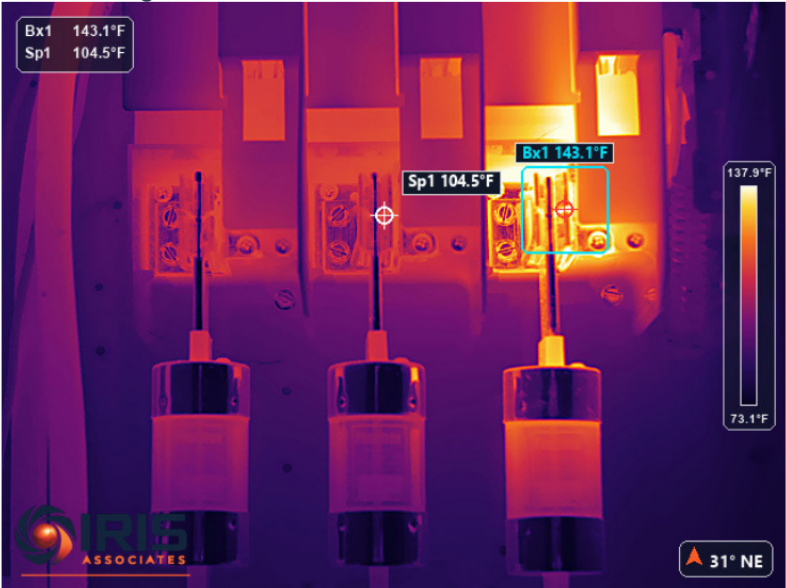
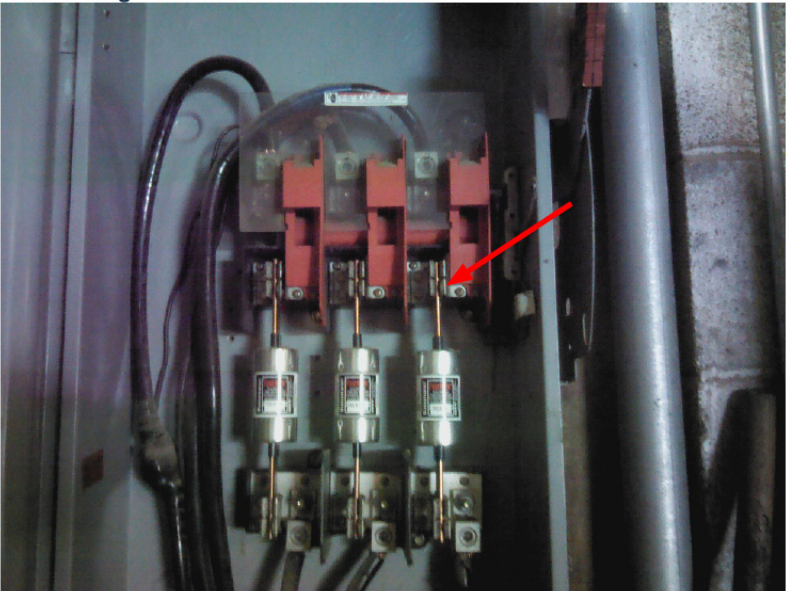
Process Equipment Disconnect

MEDIUM PRIORITY

| Measured Temp<br>143.1 °F | Reference Temp<br>104.5 °F | Delta T<br>38.6 °F |

The right fuse connection is operating warmer than the comparable fuse holders. This localized heating may indicate increased resistance at the fuse clip or termination.

Remove The Fuse And Inspect The Fuse Body, Fuse Holder, Clips, And Associated Hardware For Signs Of Overheating, Looseness, Contamination, Or Damage. Clean And Repair As Necessary. Verify Proper Fuse Holder Tension Before Reinstallation.

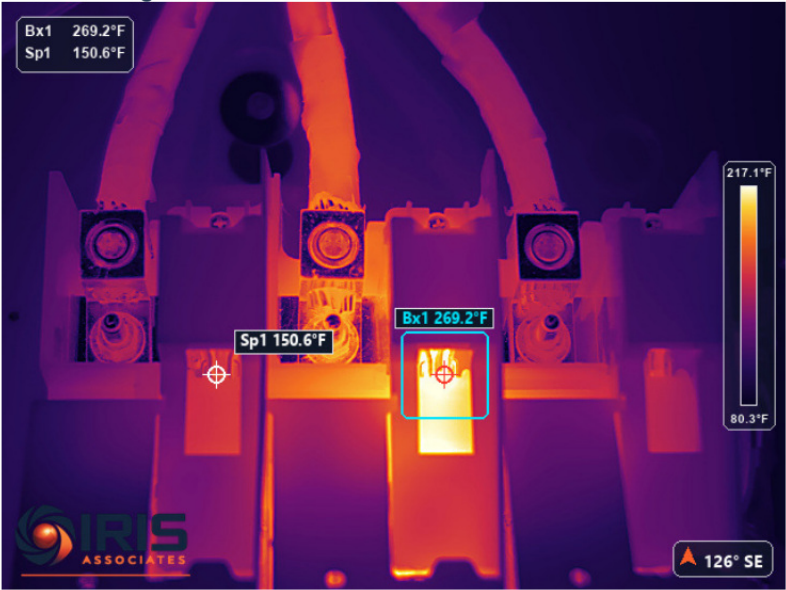
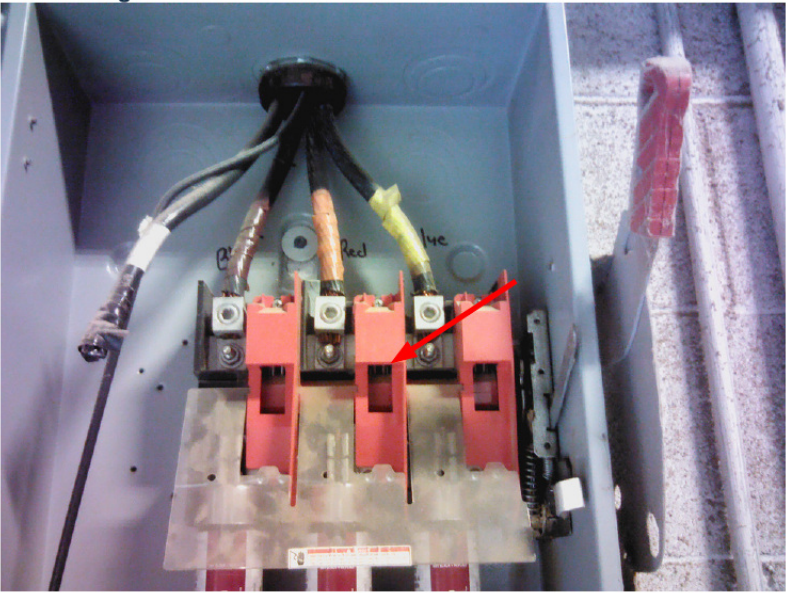
# Dust Collection System Main Disconnect

| CRITICAL / HIGH PRIORITY FINDINGS | |
|---|---|
| 4 | Dust Collection System Main Disconnect |

HIGH PRIORITY

| Measured Temp<br>269.2 °F | Reference Temp<br>150.6 °F | Delta T<br>118.6 °F |

The center switch hardware is operating substantially warmer than comparable components. The severity and localized pattern indicate a likely high-resistance connection requiring prompt correction.

Exercise The Switch If Appropriate And Inspect Hinge Contact Areas, Contact Surfaces, And Associated Hardware For Signs Of Contamination, Wear, Overheating, Or Damage. Clean And Repair As Necessary.
